BACKGROUND:

Faulty scaffold clips have been discovered at a construction site in WA. The clips have been imported from India, TURBO brand.

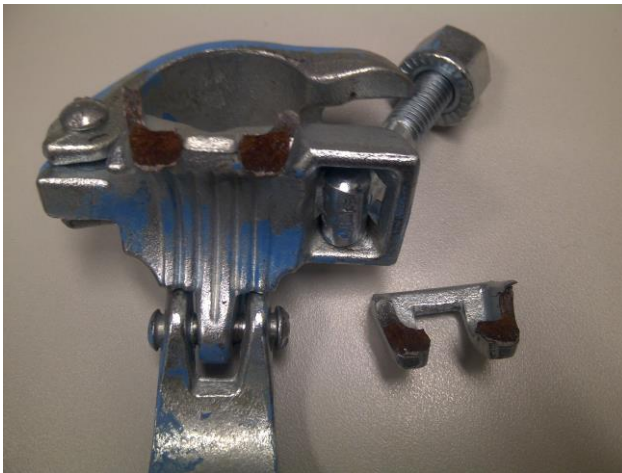
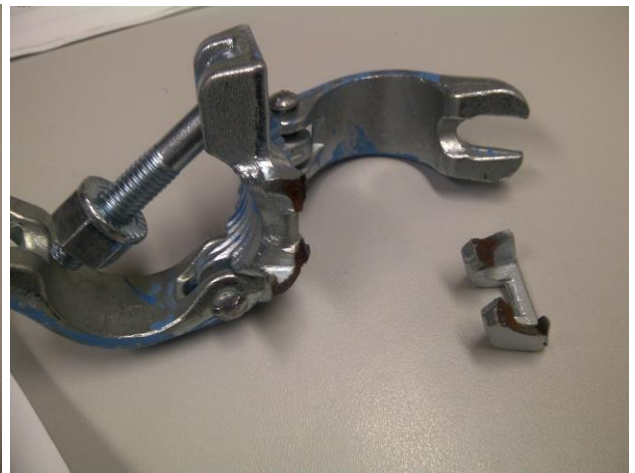
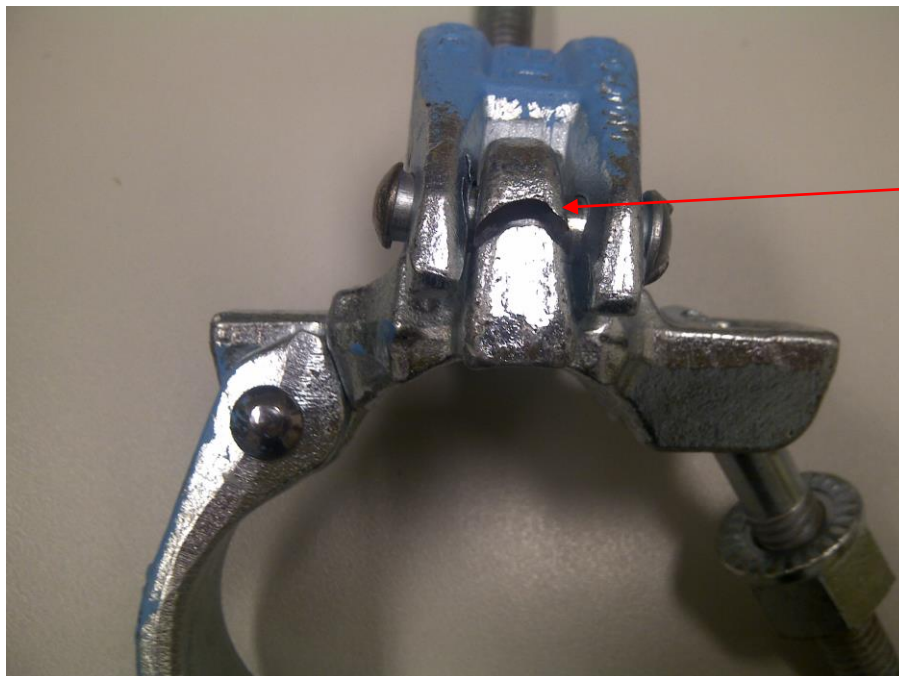
The clips do not have a batch number embossed on the clips making identification of the faulty batch impossible. There have been reported problems in the past with this brand slipping under load. An investigation is currently in progress.

Fracture

Ensure that all scaffold components manufactured by TURBO are thoroughly inspected before use and that the supplier is notified of any deformations or defects.
