CFMEU ALERT

FORMWORK SHUTTER & LIFTING POINTS

On Monday 31st Oct 2011, a 65 yr old Formwork Foreman was fatally injured on a project at the Queensland University Campus St Lucia, when a concrete formwork shutter being lifted by a crane suffered a catastrophic failure at the lifting points.

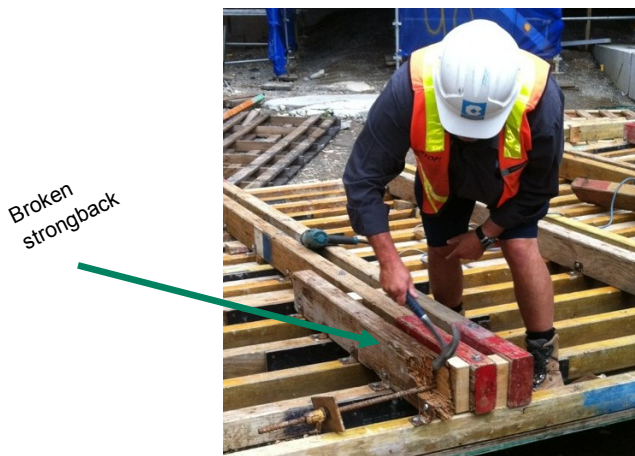
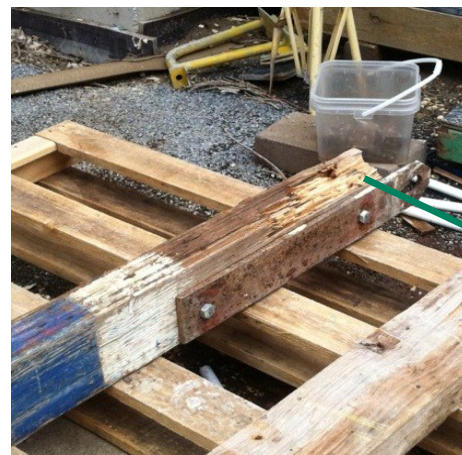
It would appear the shutter was being extended in height by at least the width of a sheet of form ply, and was going to be used to form a higher wall. Extra strongbacks that were not part of the original shutter design had been fitted and were some 1.2-1.5 metres higher. It is believed that the shutter was in the process of being lifted up by a crane to turn it over to fit the extra soldiers and form ply needed for the extended height, when the failure happened.

The extended strongbacks appear to have failed under the extra load exerted by the lateral force of the attached lifting chains causing the shutter to tragically fall on the worker.

Ensure that Engineers approval is received and verified on the design and construction of all Formwork shutters.

All lifting points are be part of that approval, and a record of maintenance and use must be available for inspection at any time.

Any modifications to the original engineer approved design of any Formwork shutter must be approved and verified again by an engineer before use.

All contractors and supervisors to be aware of their obligations when making , modifying or lifting Formwork shutters.
