SAFETY ALERT

SCAFFOLDING HOP-UP BRACKET TIE BARS

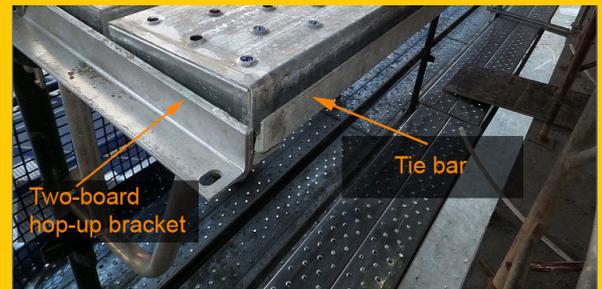
There have been a number of incidents in Queensland where tie bars have become inadvertently detached and workers have either fallen or been struck by a falling tie bar.

Any single inadvertent force should not be able to dislodge any part of the tie bar. For example, a bouncing motion caused by an object falling down on the scaffolding deck or an inadvertent vertical or horizontal force should not be able to dislodge the tie bar.

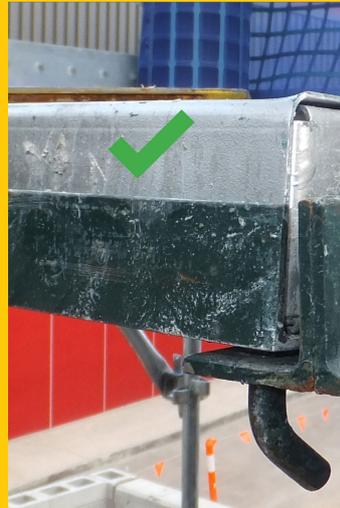
Example (a) - Preferred

Tie bar pins with 45 degree bend with end of pin pointing back towards scaffolding.

It is acceptable for the scaffolding plank to be either on top of the horizontal part of the tie bar (refer Photograph 2) or next to the tie bar (refer Photograph 3). When next to the tie bar, the tie bar can either face inwards or outwards (refer Photograph 4). In all of the examples, the tie bar should not become dislodged with one single action. If the tie bar is rotated backwards it will strike the plank.

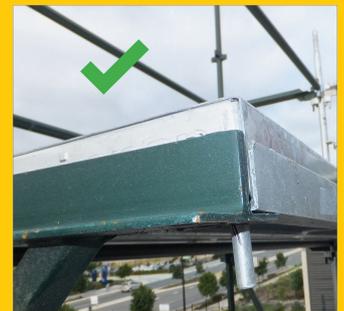
Example (b) - Preferred

Tie bar with straight pins.

The scaffolding plank is positioned on top of the horizontal part of the tie bar with the plank pushed up against vertical face of the tie bar (refer Photograph 5). In this example, the tie bar is unlikely to become dislodged as both the tie bar and the plank would have to be pushed up vertically at the same time.

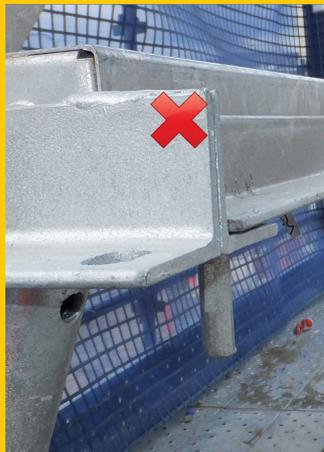
Example (c) UNSAFE

Tie bar with straight pins.

Scaffolding plank is positioned next to but not on top of the tie bar. In this example, the tie bar can become dislodged if the bar moves vertically and the plank does not resist movement.

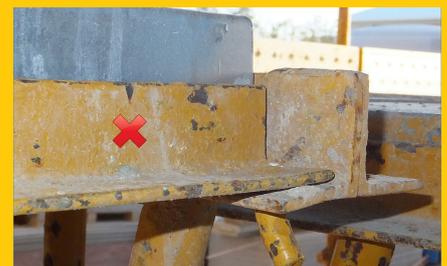
Example (d) UNSAFE

Tie bar pins with 45 degree bend with end of pin pointing away from scaffolding (refer Photograph 8). In this example, the tie bar can become dislodged if it is rotated forwards. There is no plank to resist this movement.
